Zlin Aviation S.R.O.
2. Kvetna 685
763 61 Napajedla
Czech Republic

Safety Alert	No 09	20.08.2019
---------------------	--------------	-------------------

- **Subject:**
Visual check for possible sleeves corrosion on all stainless steel wires used for ailerons, rudder, stabilizers (*) flaps controls (*).
(*) not for Shock Cub and Shock Ultra

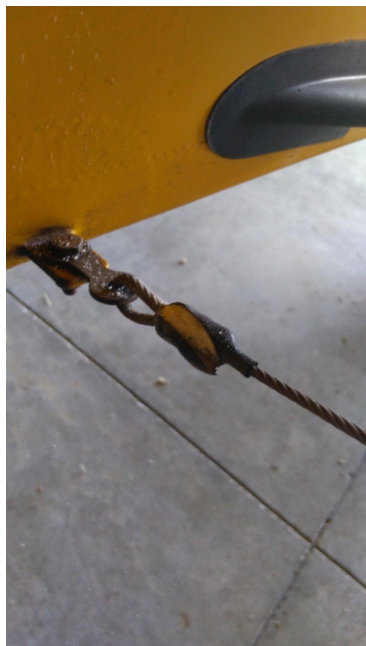
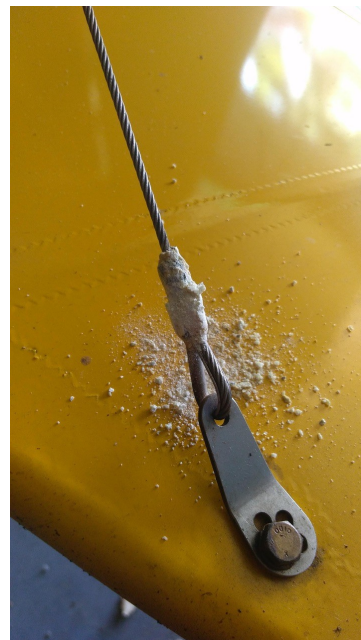
Pictures of issue occurred:

- **Reason:**
A 9 years old Savage Cub with 780 flying logged hours, always hangared and operated in proximity of the sea and so in a particular corrosive environment was checked by the owner after he noted an anomalous swelling all around the sleeves area. The black heat shrinkable tube placed during the wire assembling over the sleeves, didn't allow to notice immediately the reason of the swelling so the owner decided to cut and remove the black seal, finally founding the reason of the swelling. The attached pictures show the occurred problem and how to work on it. A deep corrosion was finally reported.

This step applies only when corrosion or any othe defects are found. If any corrosion or any other issues are found on the wires **it is mandatory to replace them all immidiately before next flight.** For new sets of replacement contact us directly and we will dispatch new sets of wires/cables for each customer affected by this issue

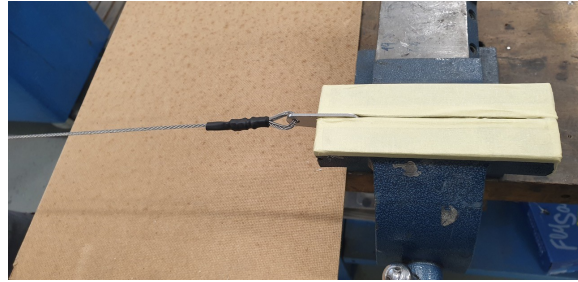
Hold the wire

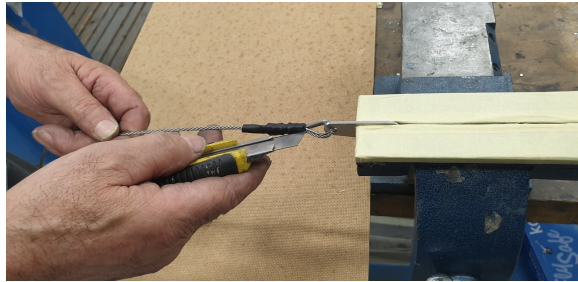
Cut the shrinkable tube

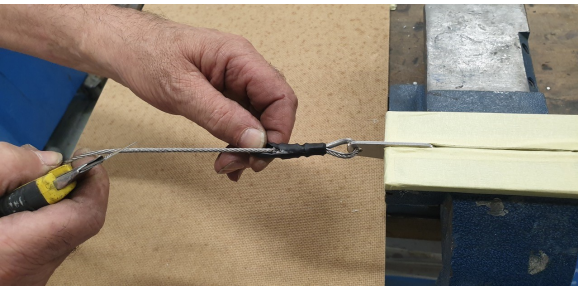
Remove the tube

Remove all heat shrink tubes from sleeves so you can see the condition of the sleeves

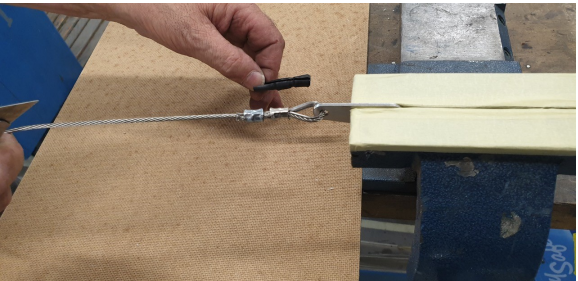
Inspect the sleeves

Check for any corrosion or other issues like degradation of the plombs due to high salt concentration in the air . If you are not sure , send us some pictures for assessment

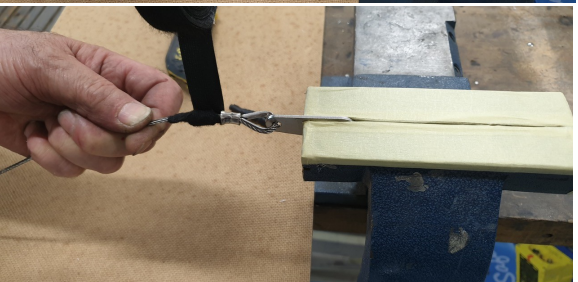
Seal the sleeves with the Tesa tape

If all sleeves are good with no corrosion on them or any other defects are found , you can seal the sleeves with Tesa tape used for wiring looms (or any other duck tape that suits the needs)

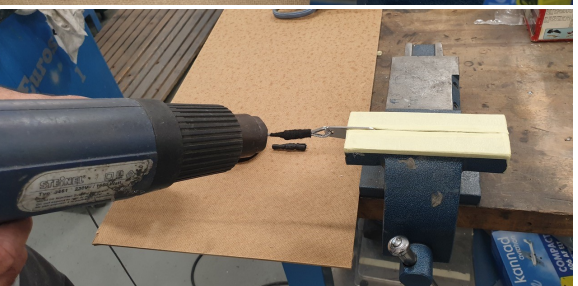
Use small amount of heat to seal it
