Safety Alert 171228

Addition of Safety Cables to Existing Parachute Retention Lines

NOTICE ID: SA171228

1.2 SUBJECT: Mandatory addition of 2 additional safety cables to existing TL-2000 parachute retention line system.

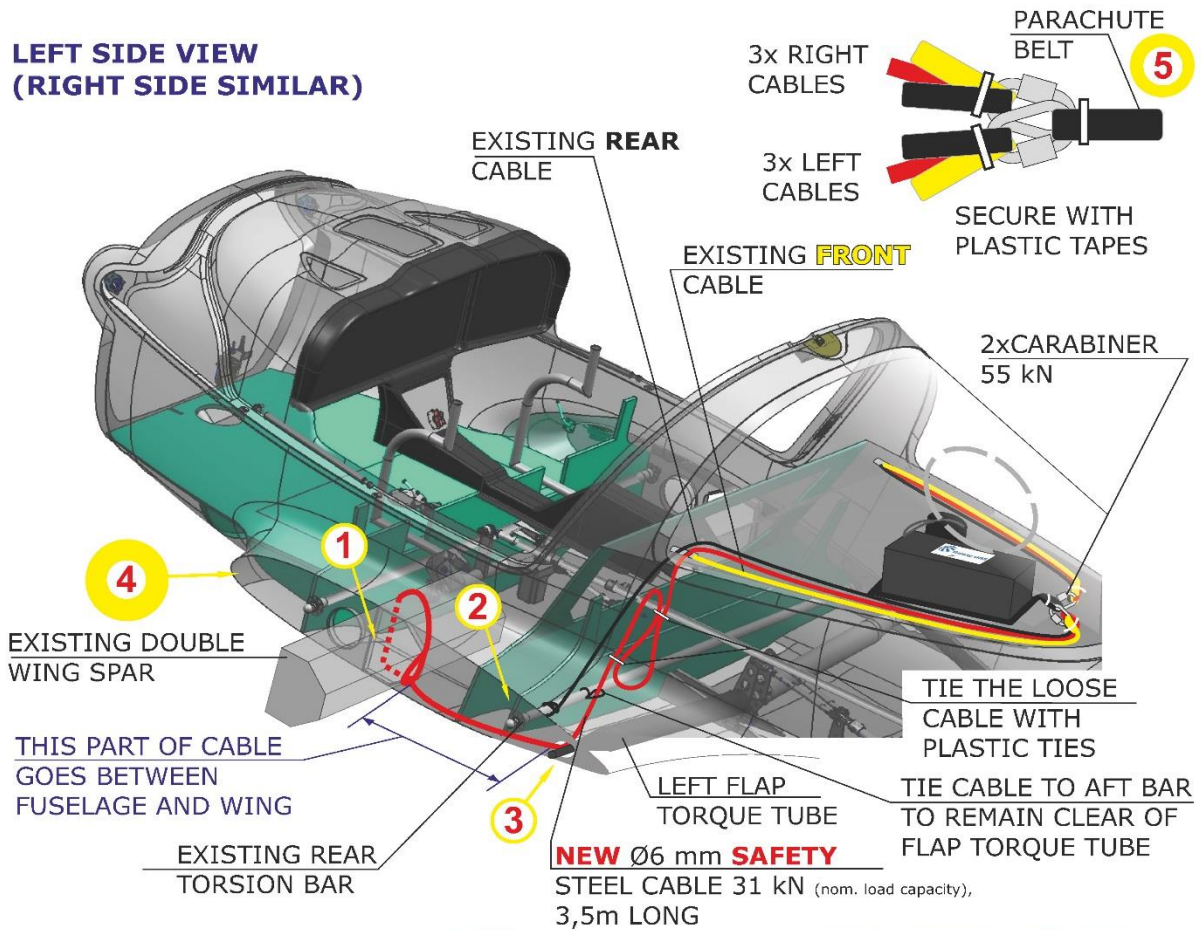
**LEFT SIDE VIEW
(RIGHT SIDE SIMILAR)**

1.7 DISCUSSION: This Service Alert establishes procedures to add two (left & right) 6mm backup safety cables from the aircraft spars to the existing GRS parachute attachment system.

- E. Experience has indicated that environmental conditions affect the internal core of the cables. Aircraft stationed, at any time, in high humidity or salt air environments will accumulate internal corrosion which will reduce ultimate cable strength.

5. Push the large loop end on the of safety cable forward under both spars, then up and aft. See the drawing for orientation assistance.
 6. Pass the small loop end of the cable through the large loop end so that the cable aims aft and low and captures both spars in a large 'lasso'. Secure the created lasso loop around the spars with plastic ties. See figure 1 on the attached drawing

7. Extend the remaining end of the cable out of the lower (under the seats) cabin area then aft of the second spar and to the outside of the fuselage. Remove any slack and secure it in place with plastic ties. See the attached drawing, figure 1.

11. Back inside the aft fuselage, take up the cable slack from the wing and secure the cable to the aft torsion bar inside the fuselage. Tie the cable in two locations to prevent any interference with the movement of controls, wires, lines or the flap torque tube. (The existing aft chute cables are also attached to the outboard ends of this torsion bar.) See the attached drawing for details.
